## Feasibility Report

### **2025 Pavement Management Program Falcon Woods & Northome Pavement Management Project Project FH 25-01**

Prepared by: Erik Henricksen  
City Engineer  
City of Falcon Heights

Project B2410775

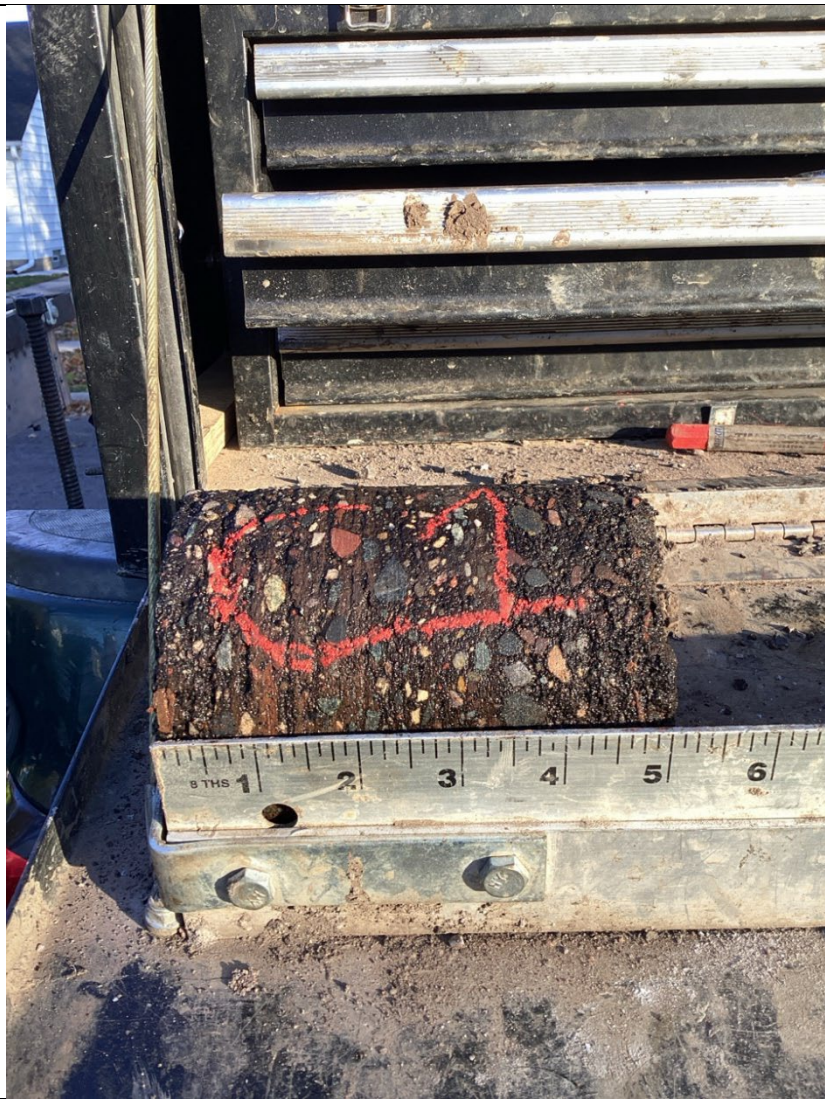
Core #: C-1  
Pavement: 5 inches      Agg Base: 11 inches  
Location: California Avenue  
Date: November 18, 2024

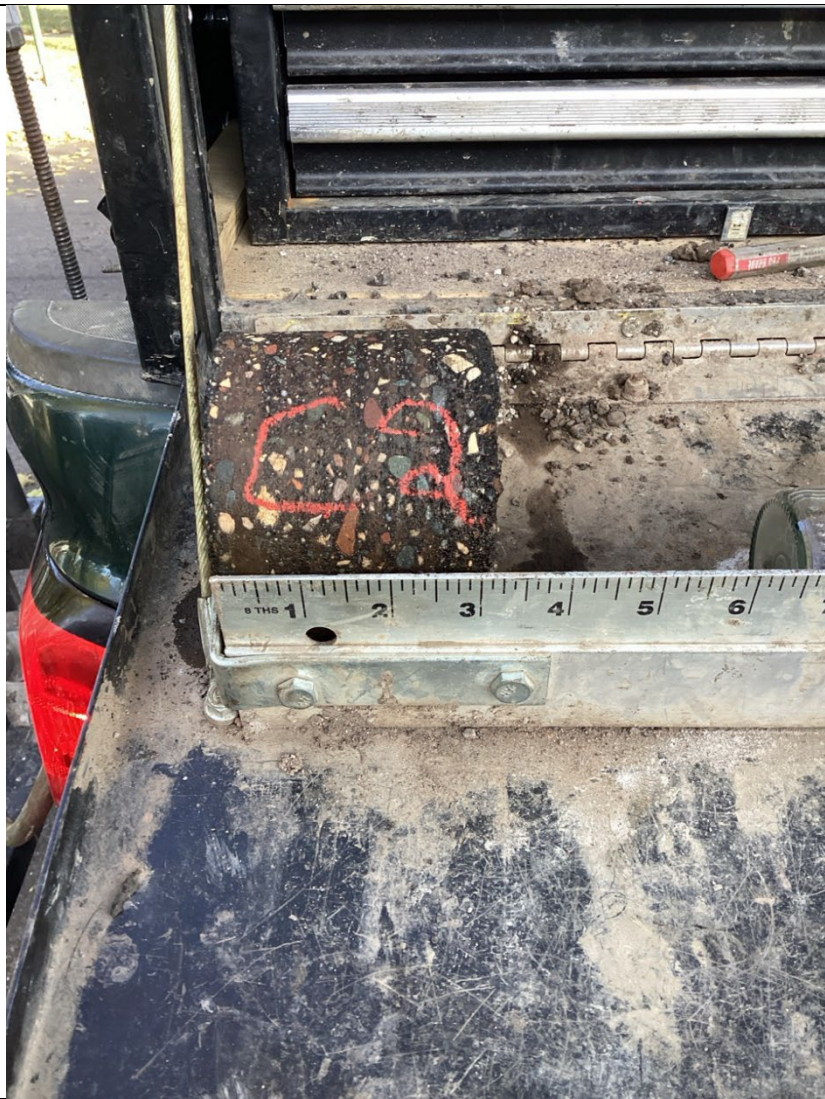
Core #: C-2  
Pavement: 3.25 inches    Agg Base: 17.75 inches  
Location: California Avenue  
Date: November 18, 2024

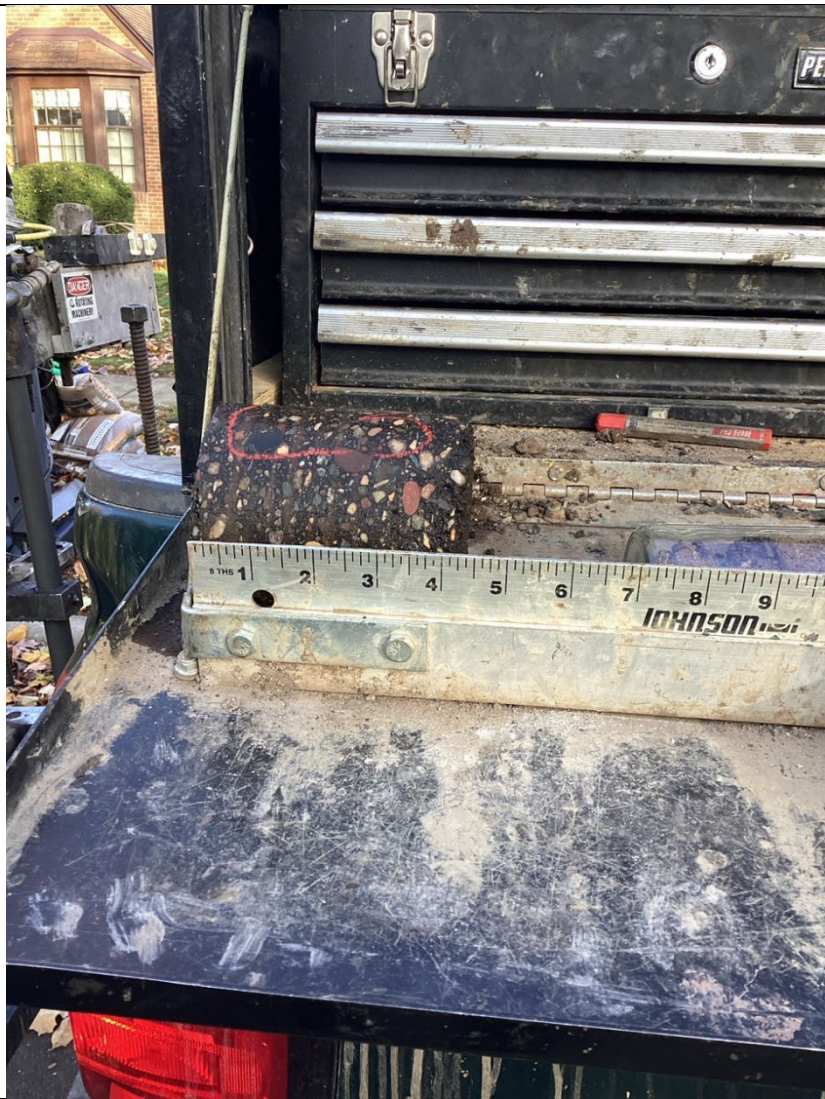
Core #: C-3  
Pavement: 4 inches      Agg Base: 12 inches  
Location: California Avenue  
Date: November 18, 2024

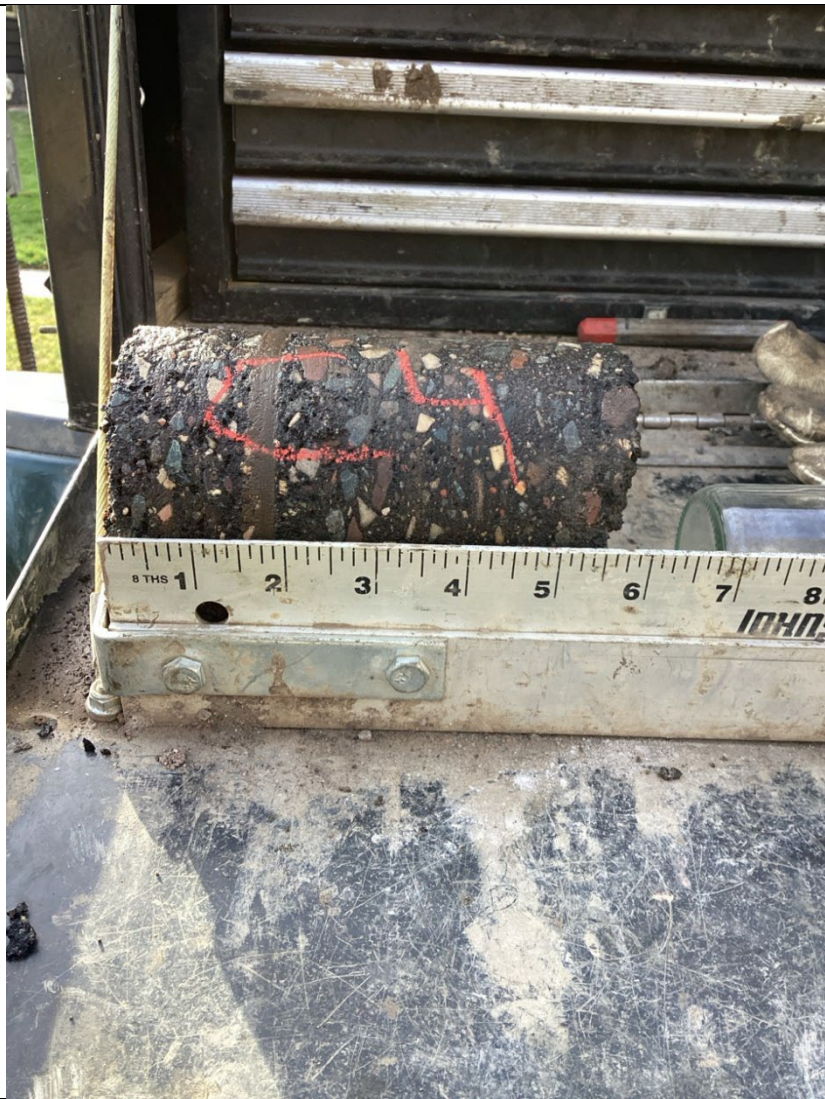
The observed pavement depth in the Northome area was generally 3.5 inches. The thicker pavement observed at C-4 from the table below was likely due to a roadway patch. Observed aggregate base ranged from 4.25 to 18.5 inches. The fill encountered below the base consisted of silty and clayey sand with variable amounts of gravel. The geotechnical report found the pavement cores analyzed were experiencing low to severe stripping, which represents the deterioration of the asphalt/aggregate bond in a bituminous pavement. When bituminous pavements exhibit moderate to severe degrees of stripping it is a key indicator the pavement has reached the end of its lifespan (8 of the 11 cores were moderate to severe). The existing pavement sections are summarized in the table below:

Core #: C-4  
Pavement: 5.5 inches      Agg Base: 18.5 inches  
Location: Idaho Avenue  
Date: November 18, 2024

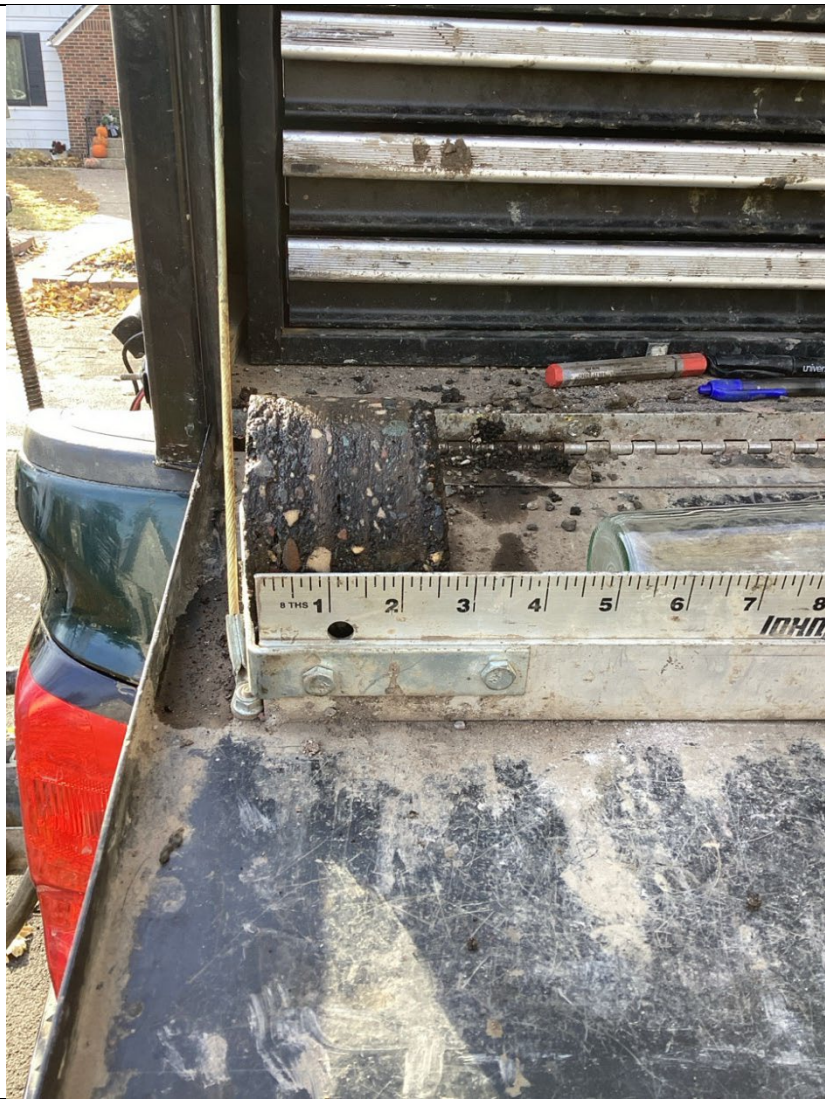
Core #: C-5  
Pavement: 2.5 inches      Agg Base: 6.5 inches  
Location: Idaho Avenue  
Date: November 18, 2024

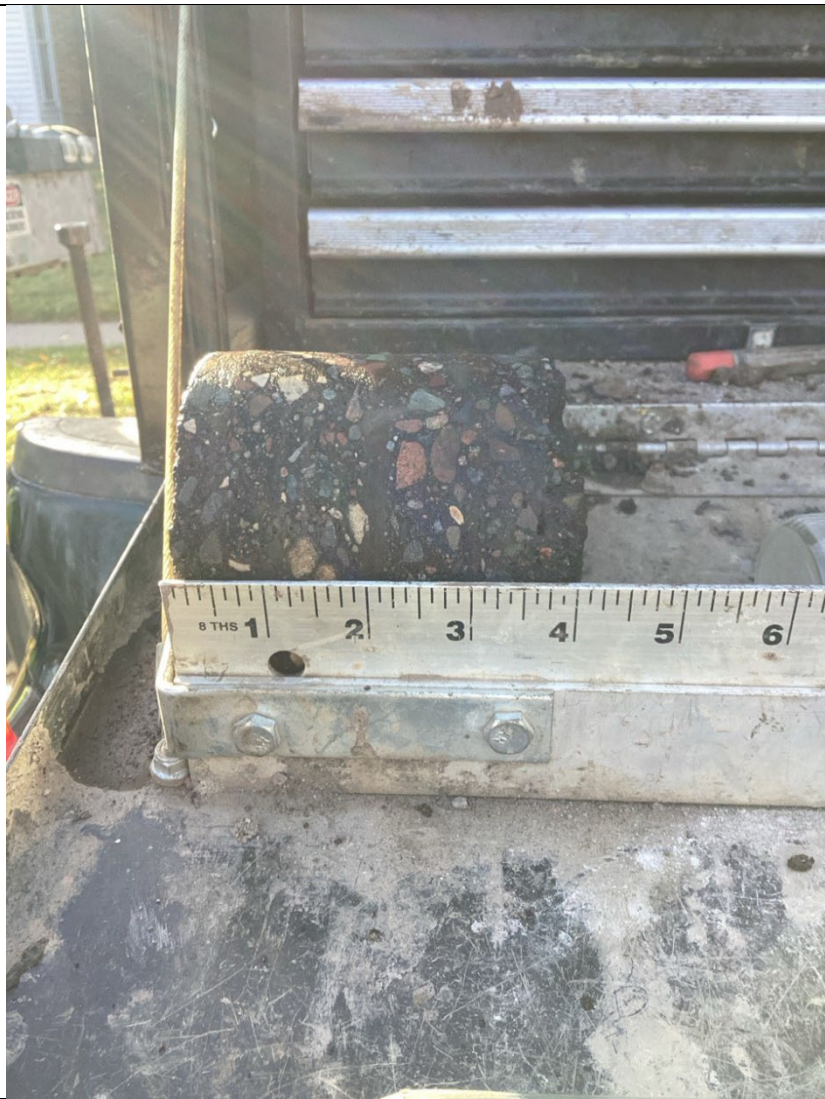
Core #: C-6  
Pavement: 4 inches      Agg Base: 14 inches  
Location: Idaho Avenue  
Date: November 18, 2024

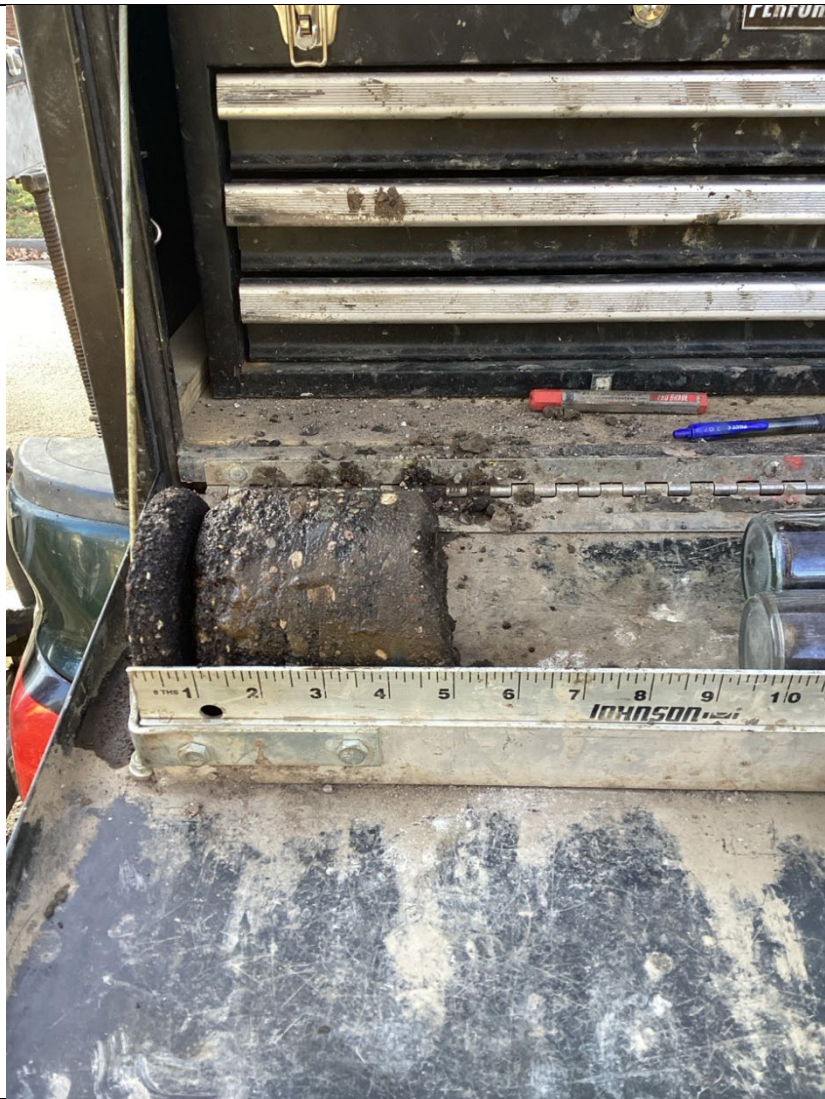
Core #: C-7  
Pavement: 4.75 inches    Agg Base: 4.25 inches  
Location: Idaho Avenue  
Date: November 18, 2024

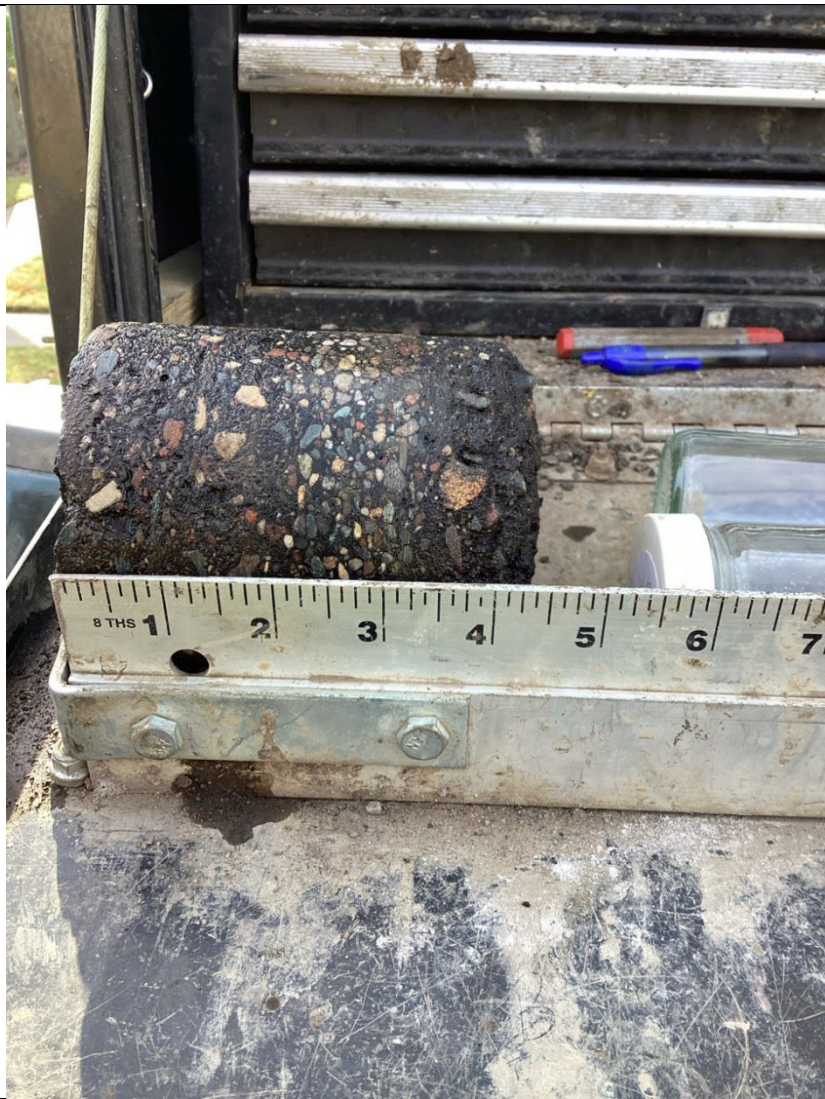
Core #: C-8  
Pavement: 4.25 inches Agg Base: 16 inches  
Location: Iowa Avenue  
Date: November 18, 2024

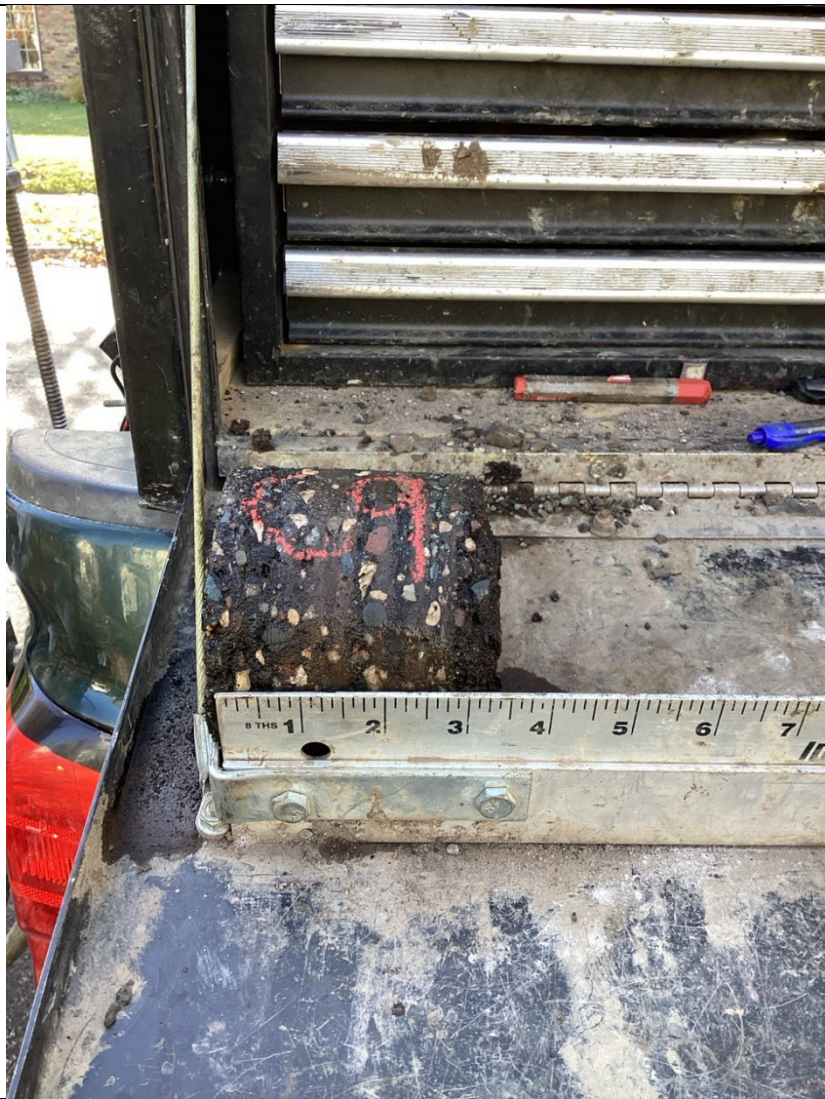
Core #: C-9  
Pavement: 3.25 inches    Agg Base: 5.75 inches  
Location: Iowa Avenue  
Date: November 18, 2024

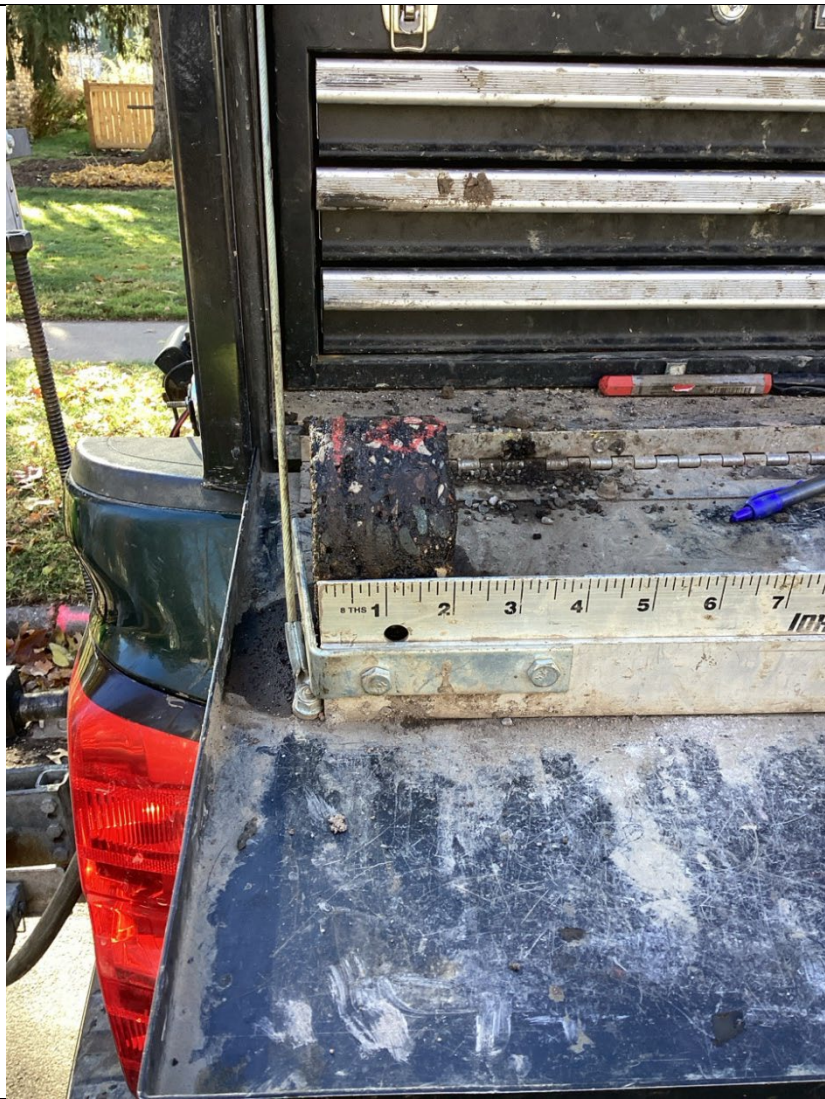
Core #: C-10  
Pavement: 2 inches      Agg Base: 13 inches  
Location: Iowa Avenue  
Date: November 18, 2024

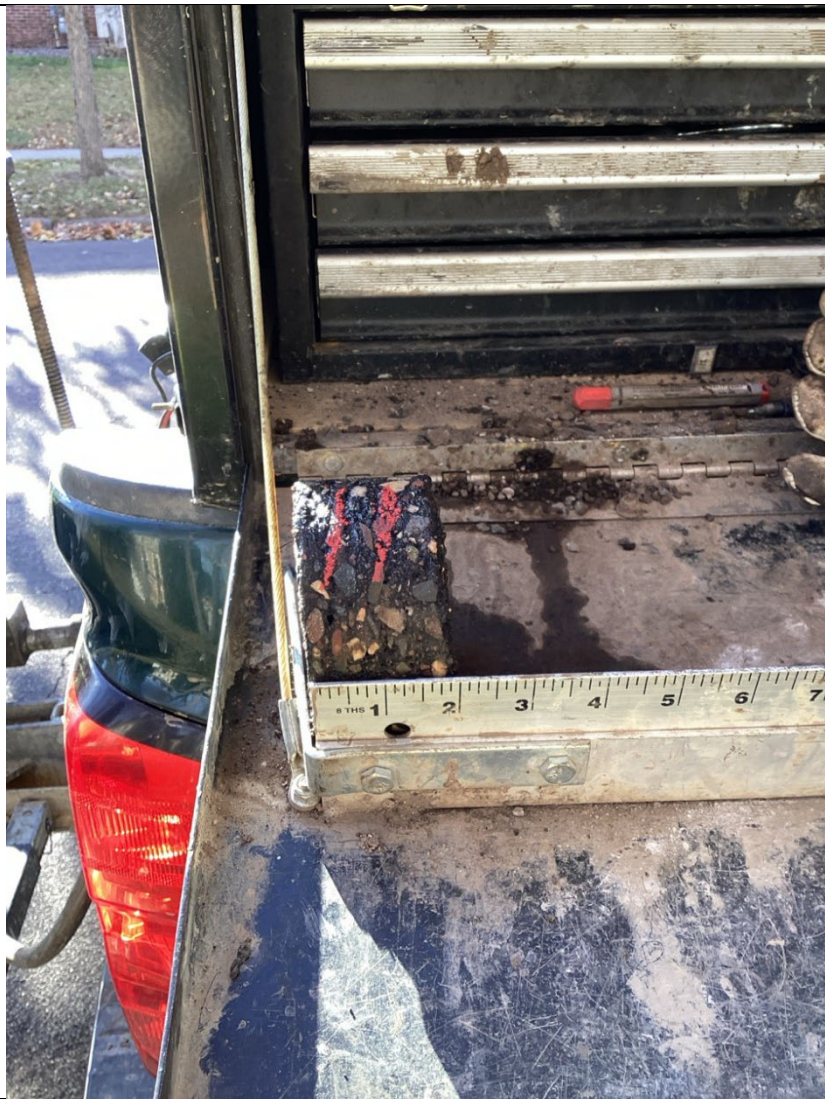
Core #: C-11  
Pavement: 1.75 inches    Agg Base: 13.25 inches  
Location: Iowa Avenue  
Date: November 18, 2024
